UNDERWATER BRIDGE INSPECTION REPORT

STRUCTURE NO. 27510

ARCOLA CHANNEL

DISTRICT 5 - HENNEPIN COUNTY

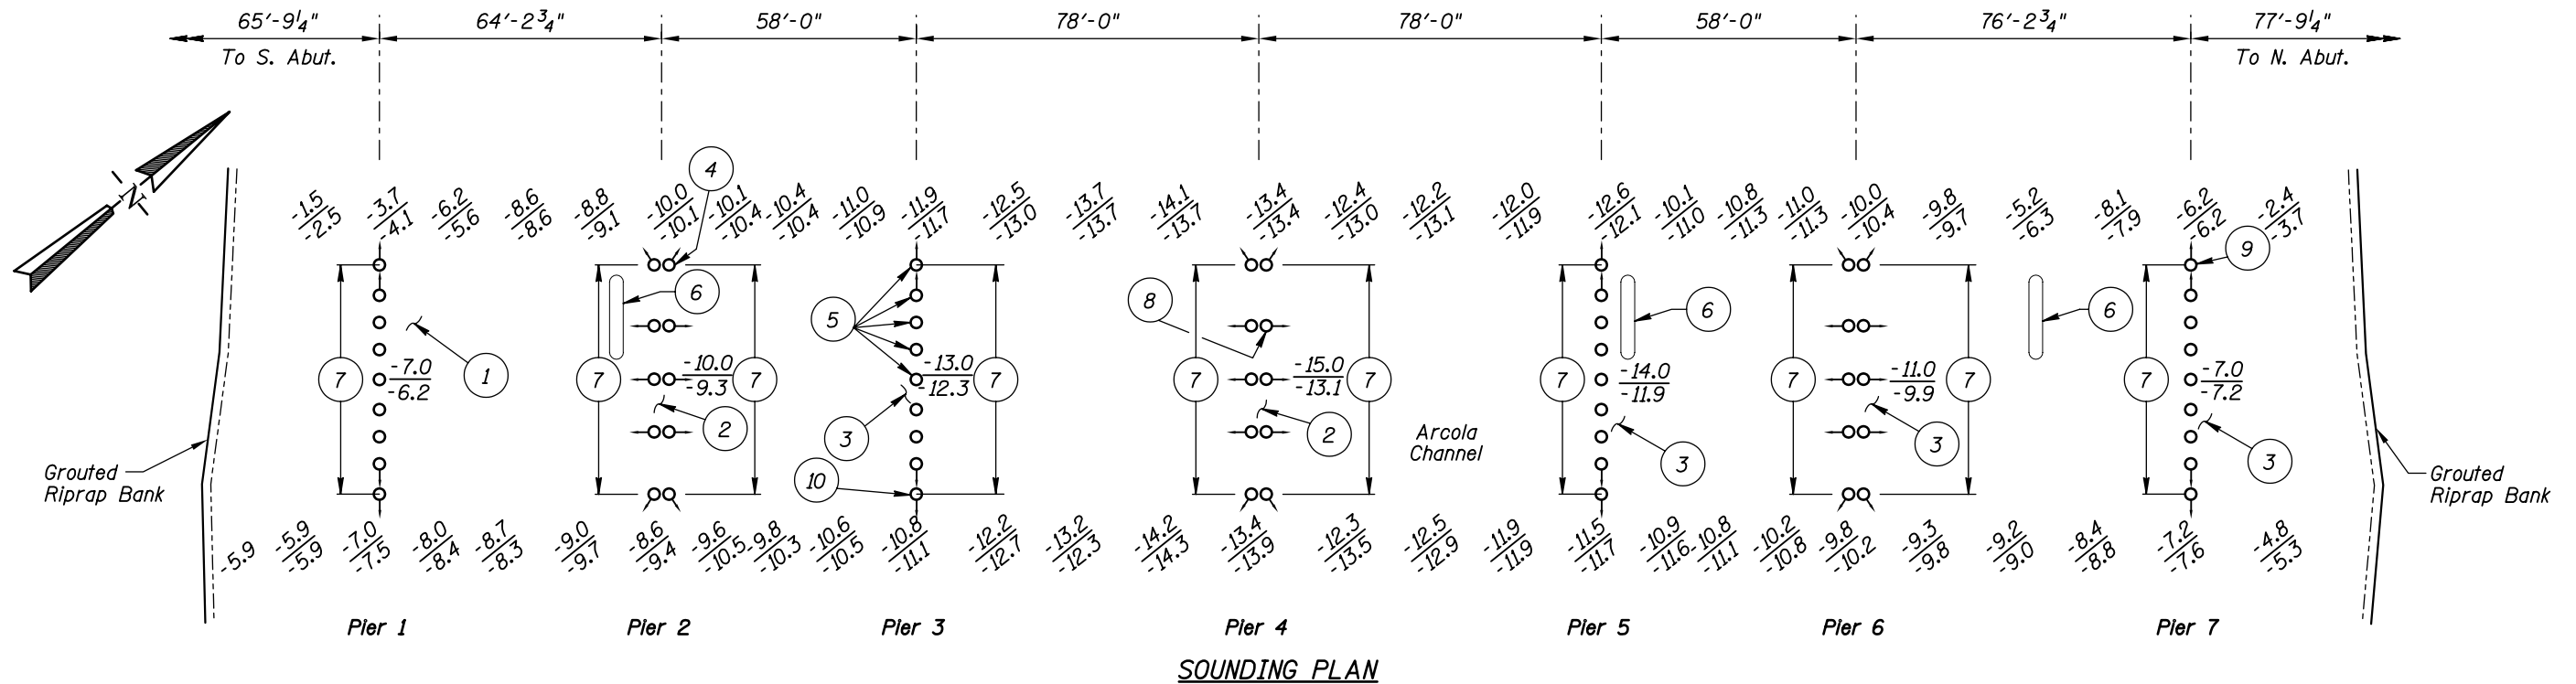
INSPECTION AND SOUNDING PLAN

- 1 The channel bottom around Pier 1 consisted of firm sand with 3 inches of maximum probe rod penetration.
- 2 The channel bottom around Piers 2 and 4 consisted of gravel approximately 1 to 2 inches in diameter.

- 3 The channel bottom around Piers 3, 5, 6 and 7 and between the piers consisted of silty sand and scattered rocks up to 2 feet in diameter.
- 4 The steel pipe pile casing exhibited a dent that was 4 inches in diameter with 2 inches of penetration and was located 5 feet below the waterline on the northwest pile of Pier 2.

- 5 Five steel pipe pile casings at the west end of Pier 3 exhibited dents that were 12 inches long with 1 inch of penetration and were located 5 to 7 feet below the waterline.

- 6 Abandoned concrete piers were encountered near Piers 2, 5, and 7 and extended approximately 1 foot above the waterline.
- 7 The steel pipe pile casings typically exhibited light to moderate surface corrosion with minor pitting up to 1/8 inch deep from 1 foot above to 1 foot below the waterline.

- 8 The steel pipe pile casing exhibited a dent 3 feet above the waterline that was 8 inches in diameter with 1/2 inch of penetration. A second 12 inch diameter dent was observed at 2 feet below the waterline, with 5 inches of penetration.

- 9 The concrete pile cap exhibited areas of section loss approximately 1.5 feet long and 6 inches high on the west end with exposed reinforcing steel on the top and bottom edges.

- 10 The concrete repair to the pile cap at the east end of Pier 3 exhibited a crack extending from the top to the bottom of the pile cap on the south face.

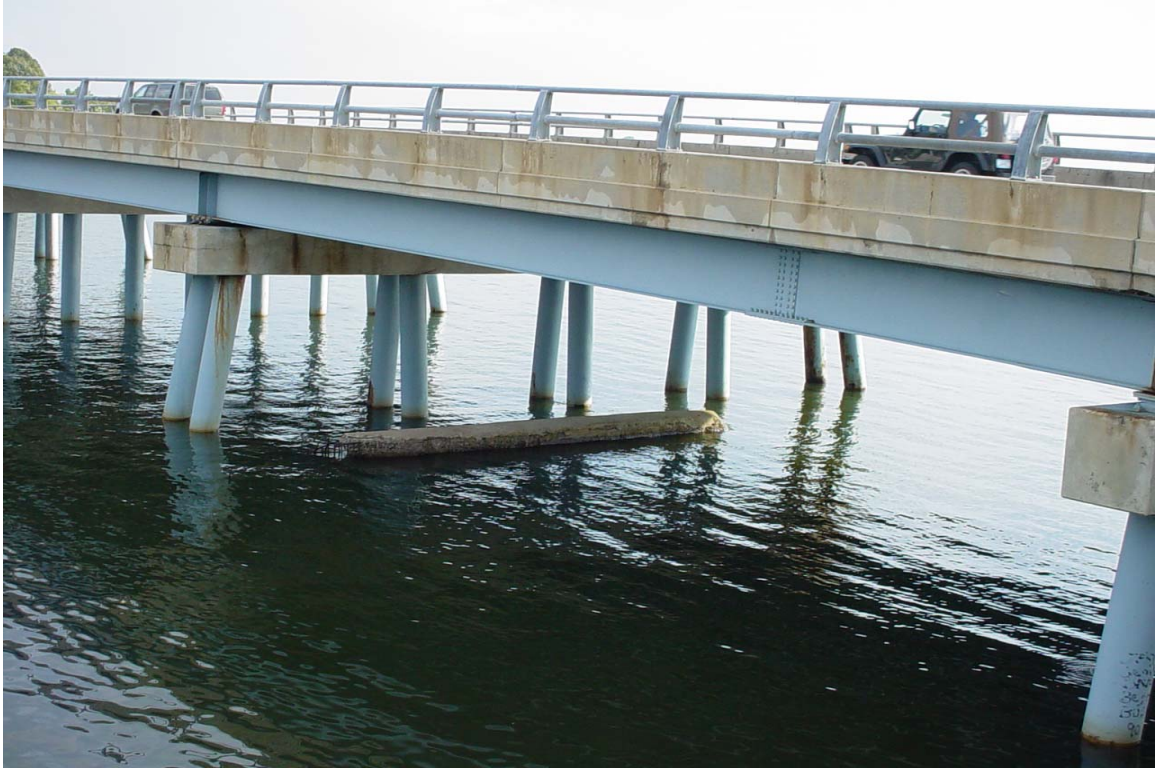
Photograph 3. View of Pier 2, Looking Northeast.

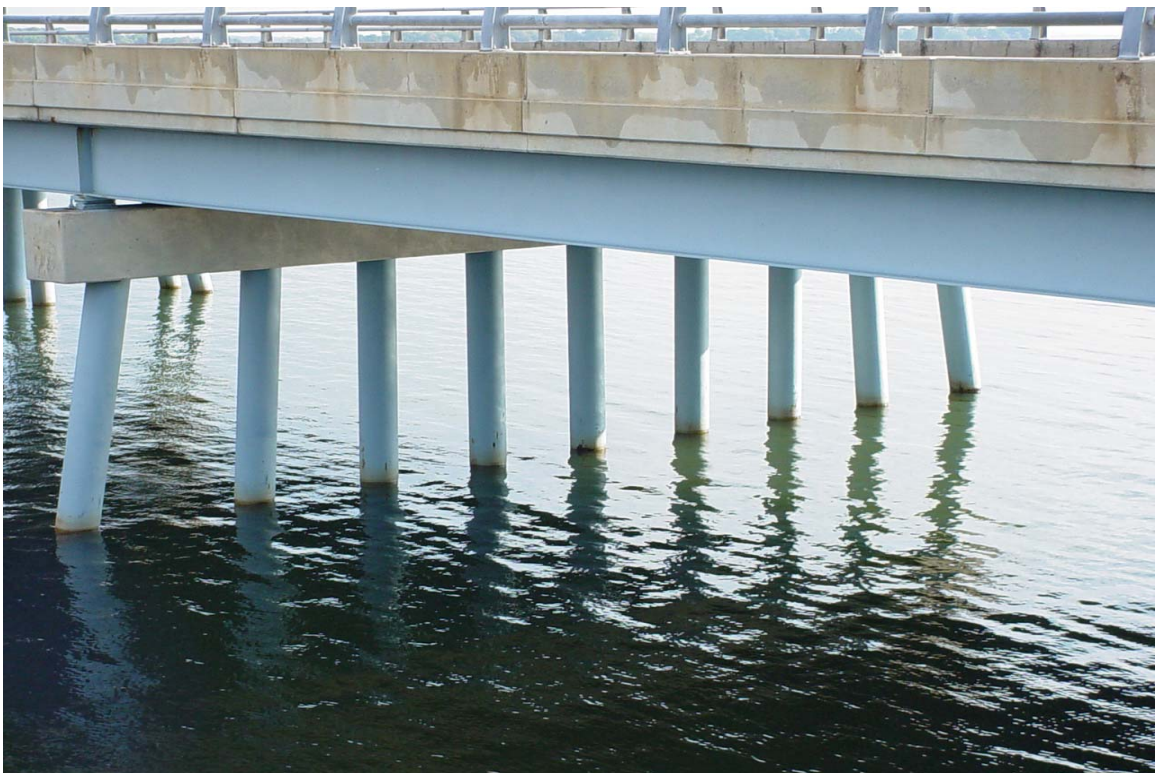
Photograph 4. View of Pier 3, Looking Northeast.
